HABS No. NY-5715-14

Governors Island, Quarters #8
Nolan Park
Governors Island
New York Harbor
New York City
New York County
New York

PHOTOGRAPHS
WRITTEN HISTORICAL AND DESCRIPTIVE DATA

ARCHITECTURAL DATA FORM

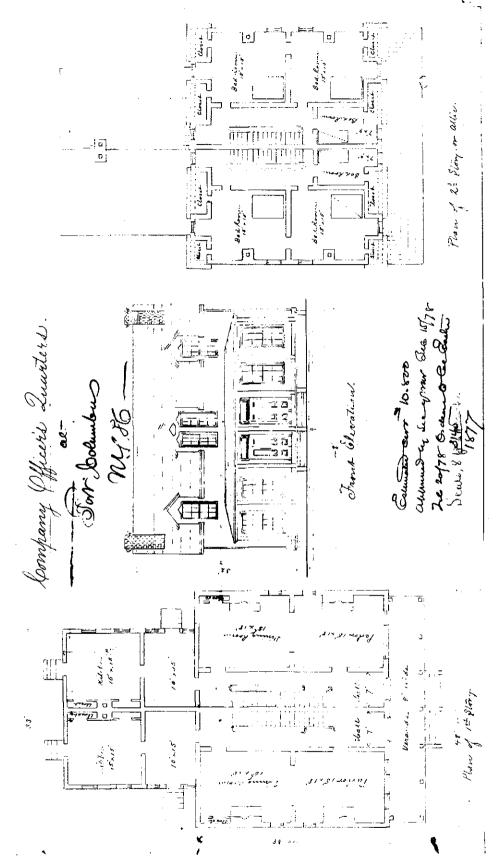
Photocopy of Drawing of Buildings #8 and #10
National Archives, Architecture and Cartographic Branch
Record Group 77-Miscellaneous Forts File
Fort Columbus, New York, Series A, #12
Plans of West Front and First and Second Floors
Unknown Delineator, 1878

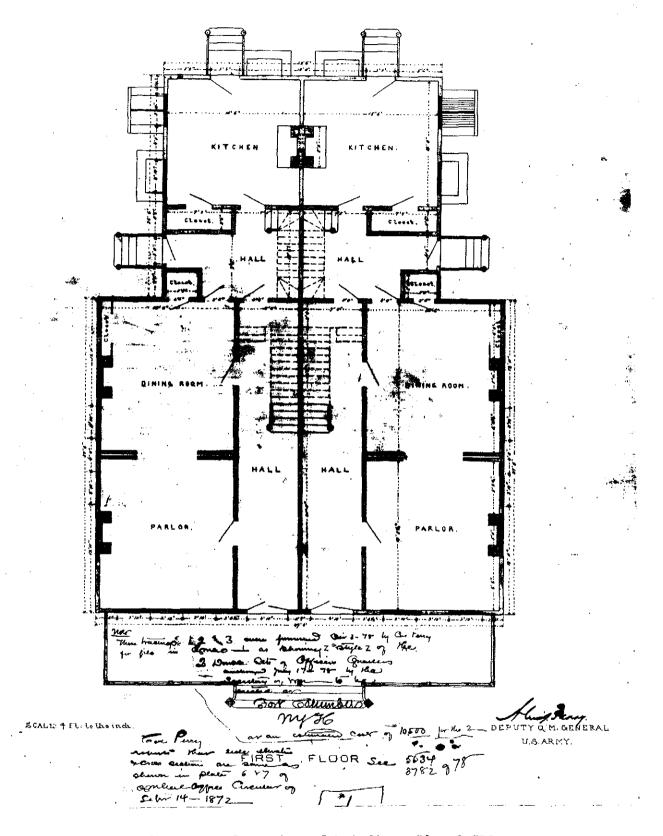
Photocopy of Drawing of Buildings #8 and #10
National Archives, Architectural and Cartographic Branch
Record Group 77-Miscellaneous Forts File
Fort Columbus, New York, Series A, #18
Plan of First Floor
Unknown Delineator, 1878

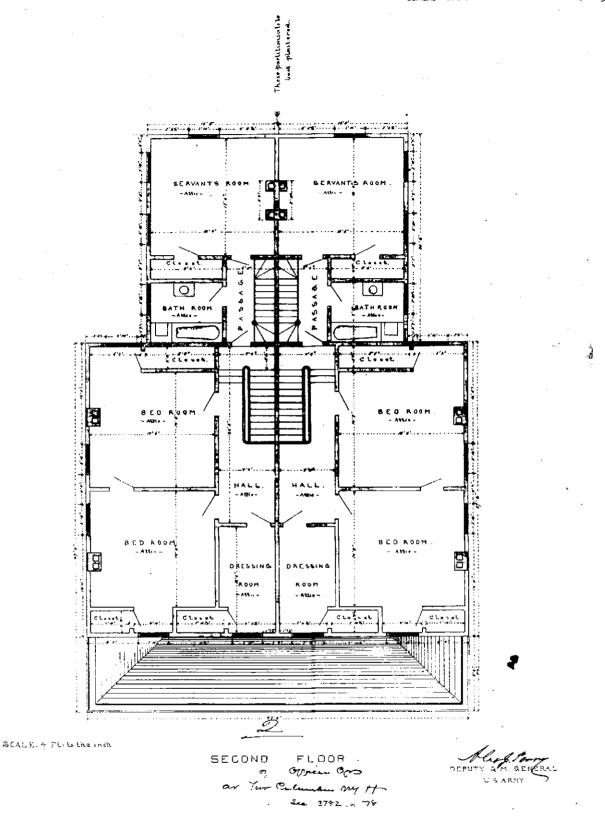
Photocopy of Drawing of Buildings #8 and #10
National Archives, Architectural and Cartographic Branch
Record Group 77-Miscellaneous Forts File
Fort Columbus, New York, Series A, #15
Plan of Second Floor
Unknown Delineator, 1878

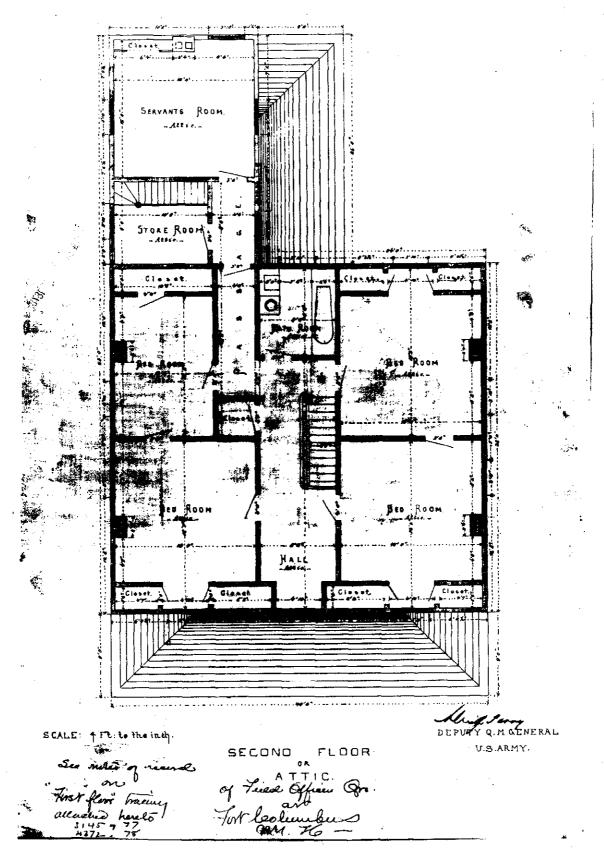
Photocopy of Drawing of Building #8
National Archives, Architectural and Cartographic Branch
Record Group 77-Miscellaneous Forts File
Plan of Second Floor or Attic
Unknown Delineator, 1878

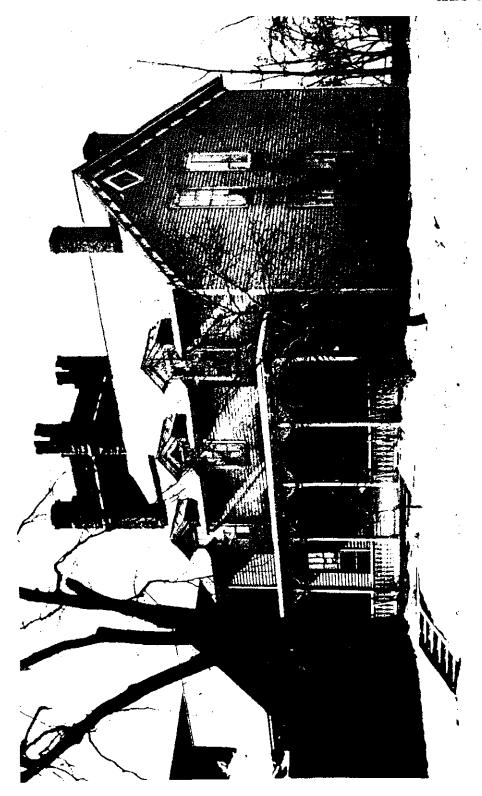
Reprint of Photograph of Building #8
U.S. Coast Guard Support Center
Special Services Division, Governors Island, N.Y., #(9864)-107007
View of West Front from Southwest
Unknown Photographer, February 14, 1934
